# Bathymetric and Velocimetric Surveys at Highway Bridges Crossing the Missouri and Mississippi Rivers on the Periphery of Missouri, July–August 2018

By Richard J. Huizinga

Scientific Investigations Report 2020–5088

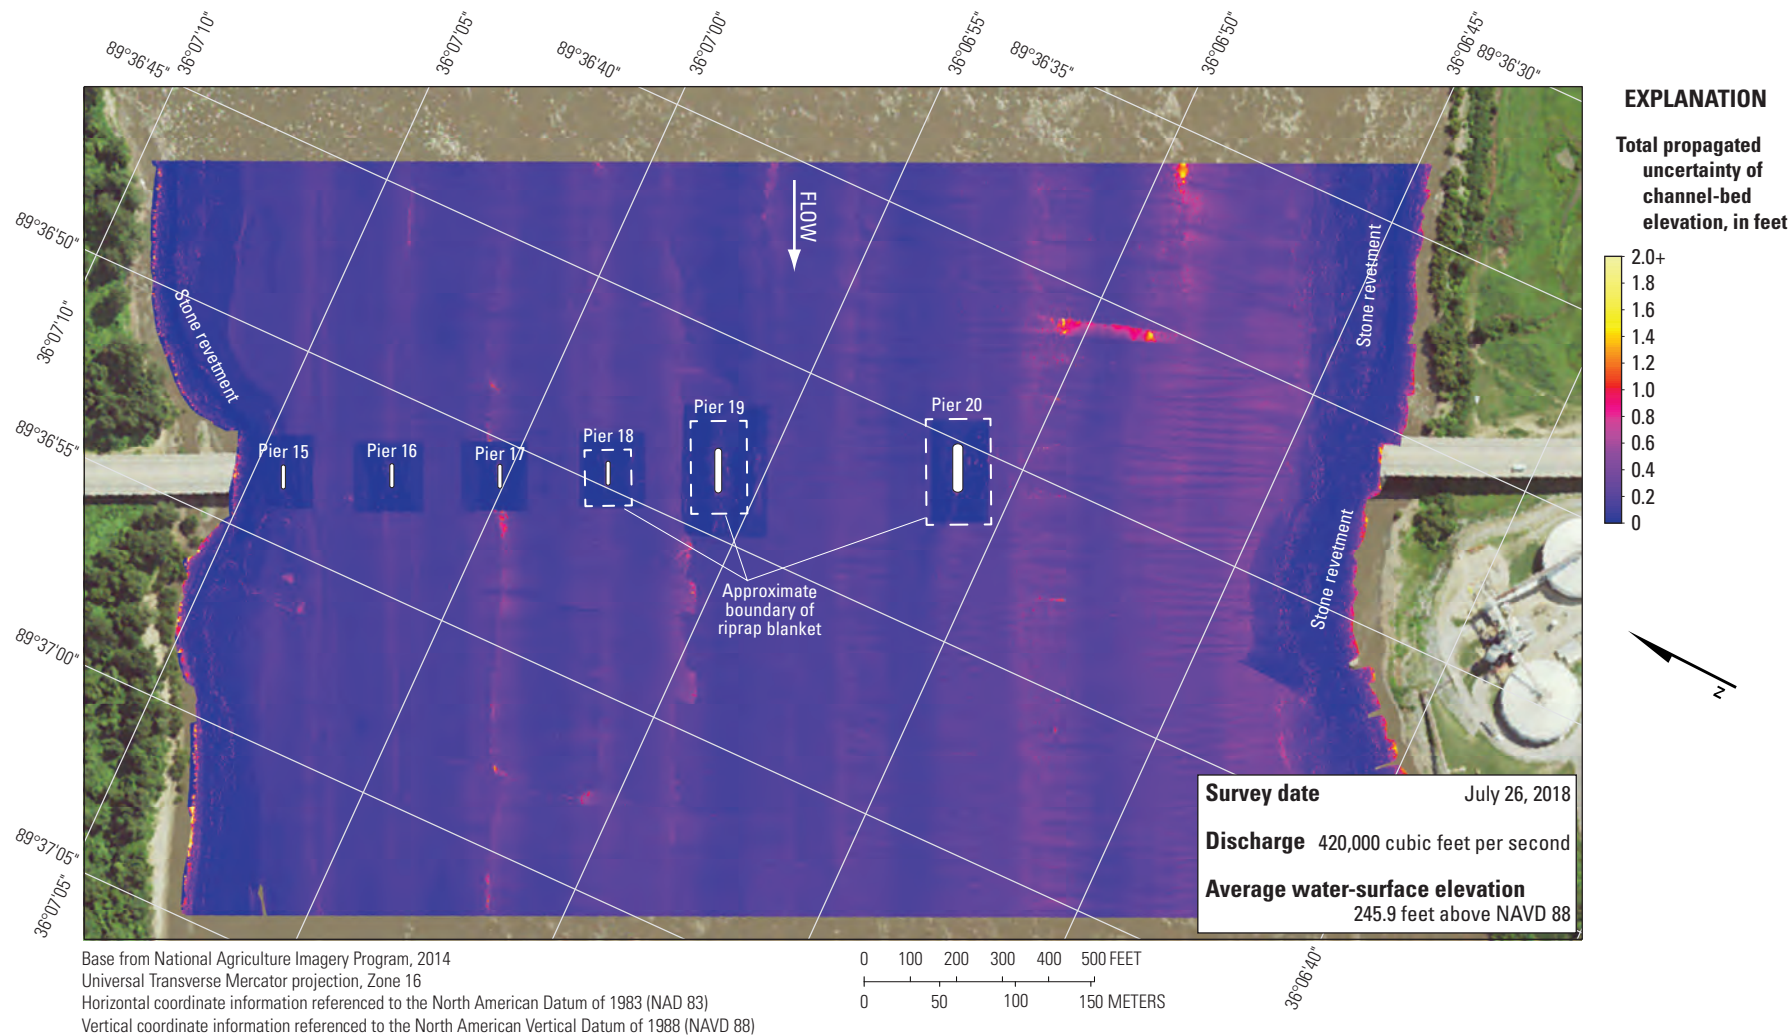
**Figure 5.** Total propagated uncertainty of bathymetric data from the Mississippi River channel near structure A1700 on Interstate 155 near Caruthersville, Missouri.

The largest TPU in this group of surveys was about 3.74 ft ([table 6](#)); however, as noted in previous studies, TPU values of this magnitude typically happened near high-relief features, such as the front or side of a pier footing ([fig. 5](#)). More than 98 percent of the TPU values were less than 0.50 ft ([table 6](#)), which is within the specifications for a “Special Order” survey, the most-stringent survey standard of the International Hydrographic Organization (IHO; International Hydrographic Organization, 2008). As has been noted in previous surveys with this equipment, the TPU values were larger near moderate-relief features (banks, spur dikes, rock riprap and outcrops, and scour holes near piers). Occasionally, the TPU values also were larger (1.00 ft or greater) in the outermost beam extents of the multibeam swath in the overlap with an adjacent swath, particularly when the MBES head was electronically tilted for the survey lines along the banks or near the piers. Overlapping adjacent swaths in the channel thalweg (the line of maximum depth in the channel) also can display larger TPU values because substantial bed movement can happen between survey passes. More than 77 percent of the TPU values were less than 0.25 ft ([table 6](#)). The tops of bridge substructural elements (pier footings and seal courses) typically had TPU values of less than 0.25 ft.

longitudinal swathes (fig. 5), which was the case at nearly all the sites surveyed in this study. The primary anomaly at this site was in the upstream mid-channel area where abrupt course changes or insufficient overlap of the swath outer beams resulted in higher TPU values. Secondary anomalies were observed along the banks, where the sonar was used in an electronically tilted configuration to extend the potential coverage in these areas, resulting in higher TPU values. Generally, the magnitude and distribution of TPU values observed at this site are representative of those observed at all the other surveyed sites.

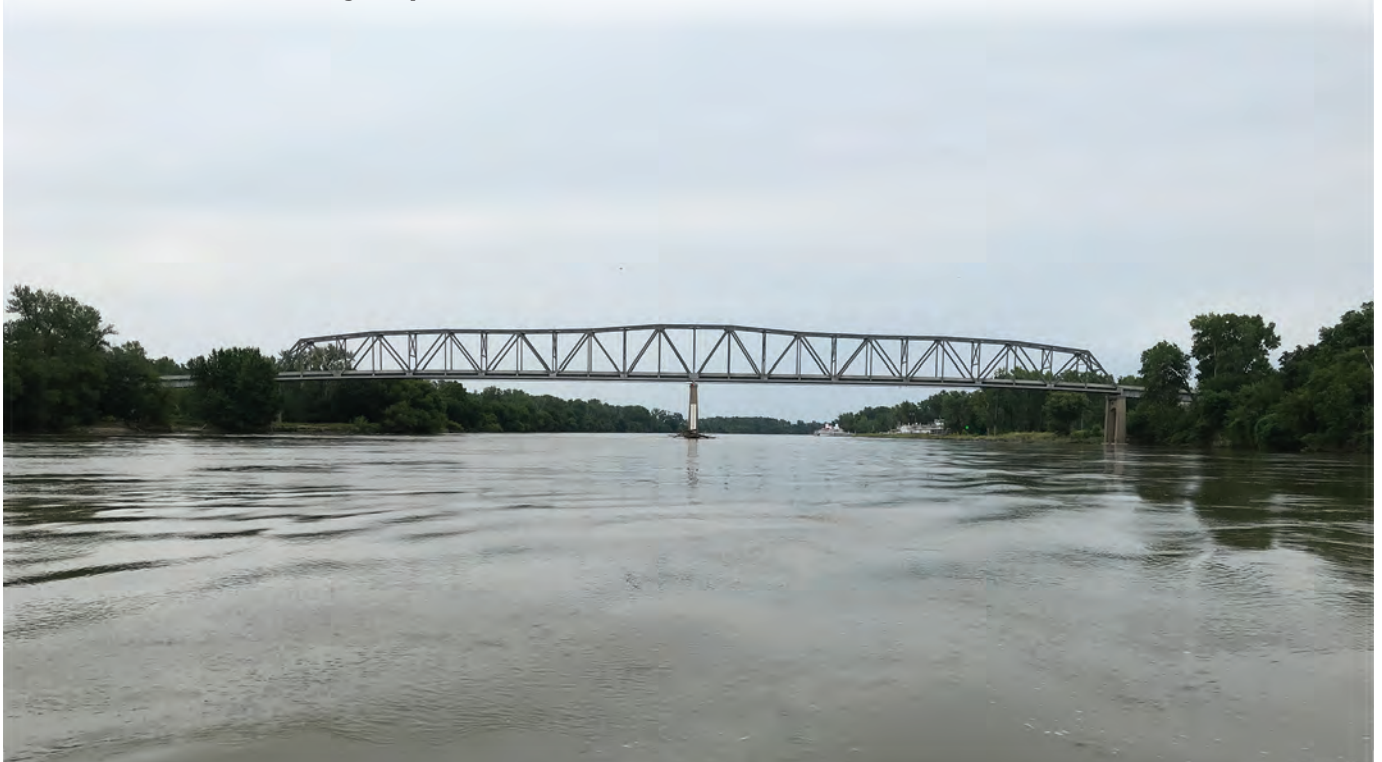
**Figure 6.** Bathymetric survey of the Missouri River channel near structure L0098 on U.S. Highway 136 at Brownville, Nebraska.

The survey area was about 1,640 ft long and about 740 ft wide, extending across the active channel from bank to bank (fig. 6). The upstream end of the survey area was about 740 ft upstream from the centerline of structure L0098. The channel-bed elevations ranged from about 863 to 881 ft for most of the surveyed area (5 to 95 percentile range of the bathymetric data; table 3; fig. 7), except near pier 3 and on the downstream sides of the various spur dikes on the left (east) bank (fig. 6). The channel bed was covered with medium and small dunes and ripples. As in previous surveys (Huizinga, 2012, 2015), a rock outcrop was present on the right (west) bank upstream from the bridge, and stone revetment was present on the right bank downstream from the bridge (fig. 6).

A local scour hole near pier 3 had a minimum channel-bed elevation of about 845 ft (table 7), about 20 ft below the average channel bed immediately upstream from the pier (fig. 6) and the overall minimum channel-bed elevation for the surveyed reach (table 3). Information from bridge plans

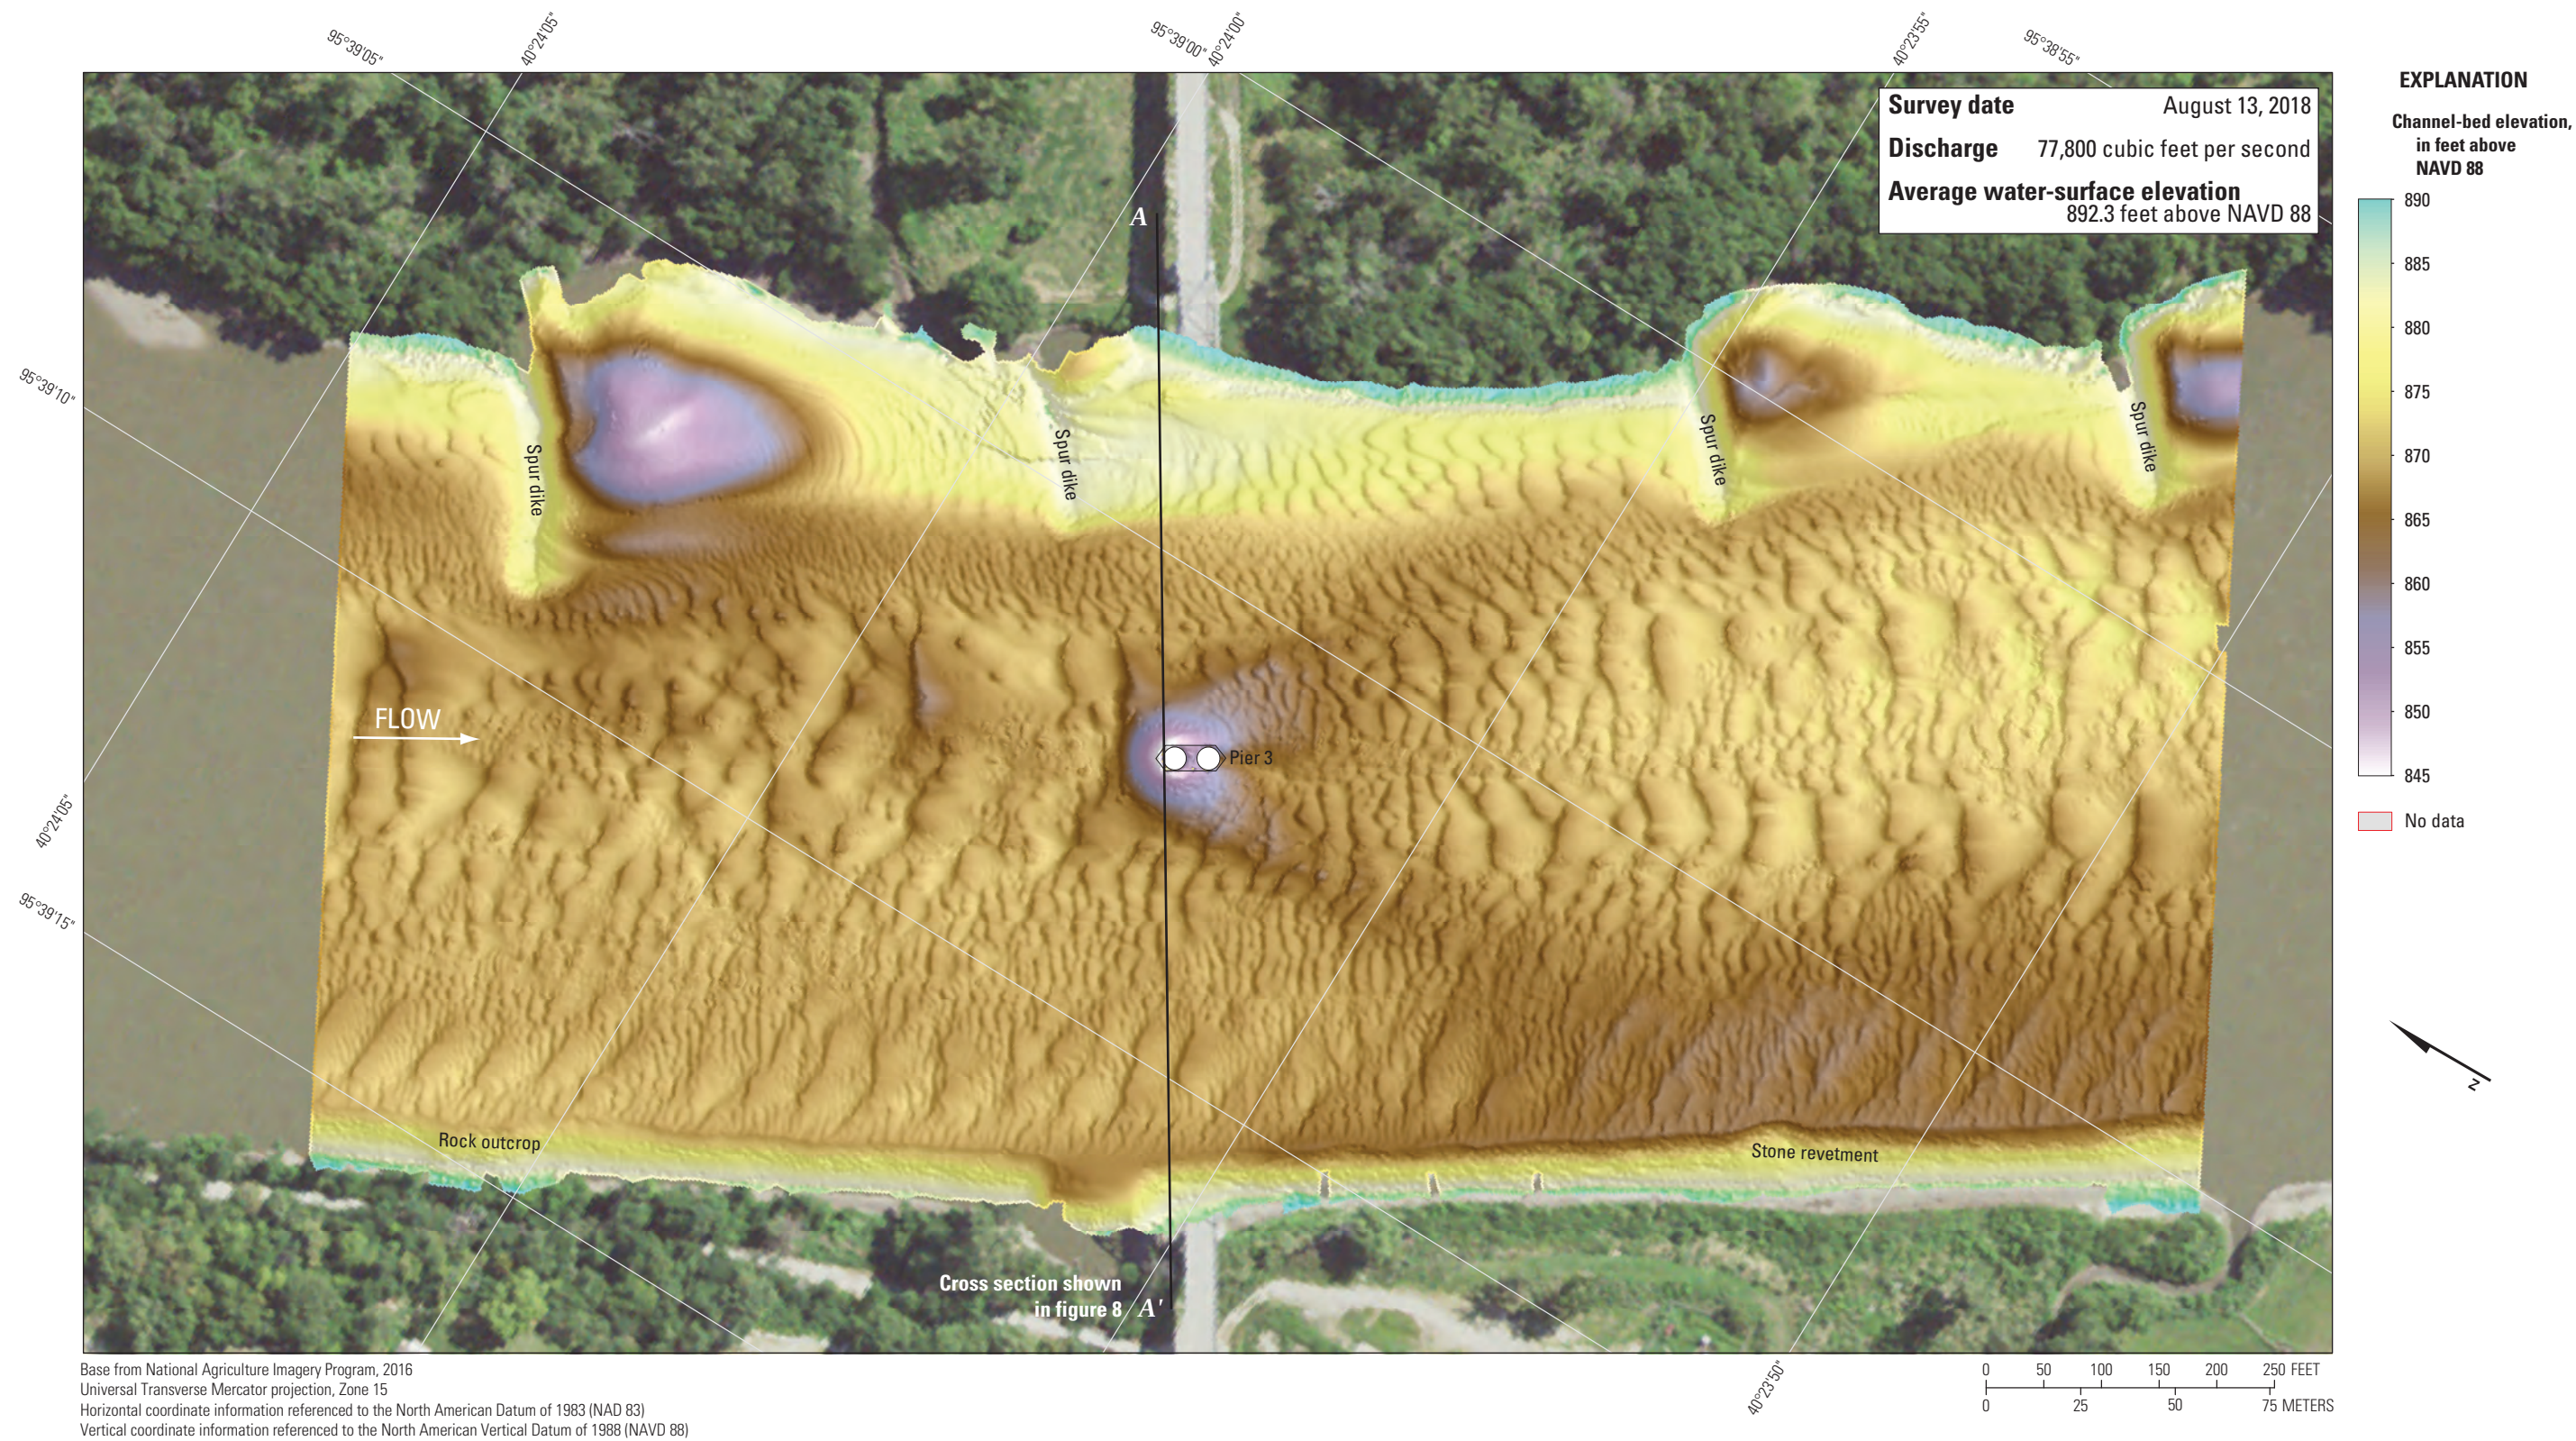
(Missouri Department of Transportation, written commun., 2002) indicates that pier 3 is founded on sheet piling caissons on bedrock, with about 30 ft of bed material between the bottom of the scour hole and bedrock at the upstream face of the pier (fig. 8; table 7). The unique configuration of the sheet pile caissons and ice breaker of the pier are clearly seen in the shaded TIN images for main channel pier 3 (fig. 1.1). The surveyed bed along the cross section generally was between the two previous multibeam surveys in 2011 and 2014, except in an area of deposition near the left bank (fig. 8).

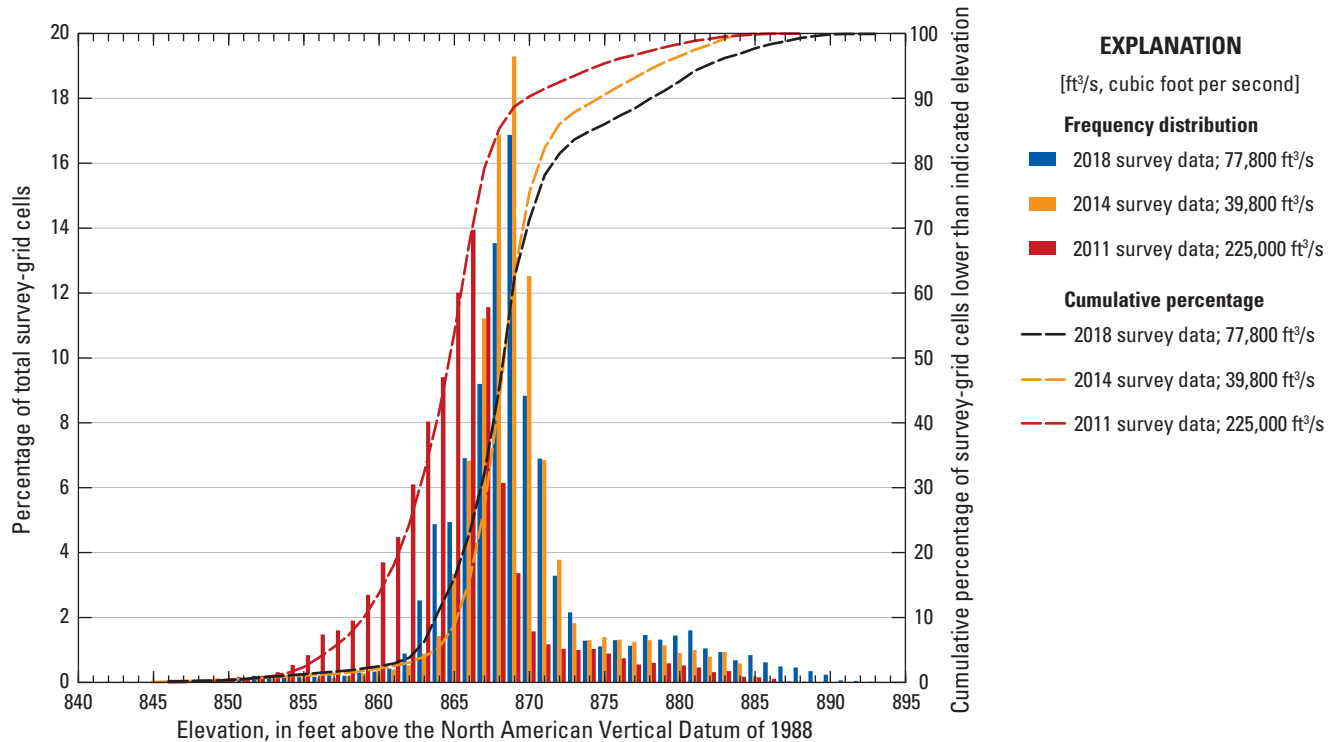
**Figure 7.** Frequency distribution of bed elevations for bathymetric survey-grid cells in 1-foot elevation bins on the Missouri River near structure L0098 on U.S. Highway 136 at Brownville, Nebraska, on August 13, 2018, compared to previous surveys (Huizinga, 2012, 2015).

and degradation between the 2014 and 2018 surveys for the area common to both surveys. The net volume of cut in the reach from 2014 to 2018 was about 43,200 cubic yards (yd<sup>3</sup>), and the net volume of fill was about 43,500 yd<sup>3</sup>, resulting in a net gain of about 300 yd<sup>3</sup> of sediment. This similarity between 2014 and 2018 is further substantiated by the frequency distribution of bed elevations (fig. 7), which clearly shows the 2018 distribution as being similar in shape to 2014, with nearly equal values at the 50 percent point of the cumulative percentage curves.

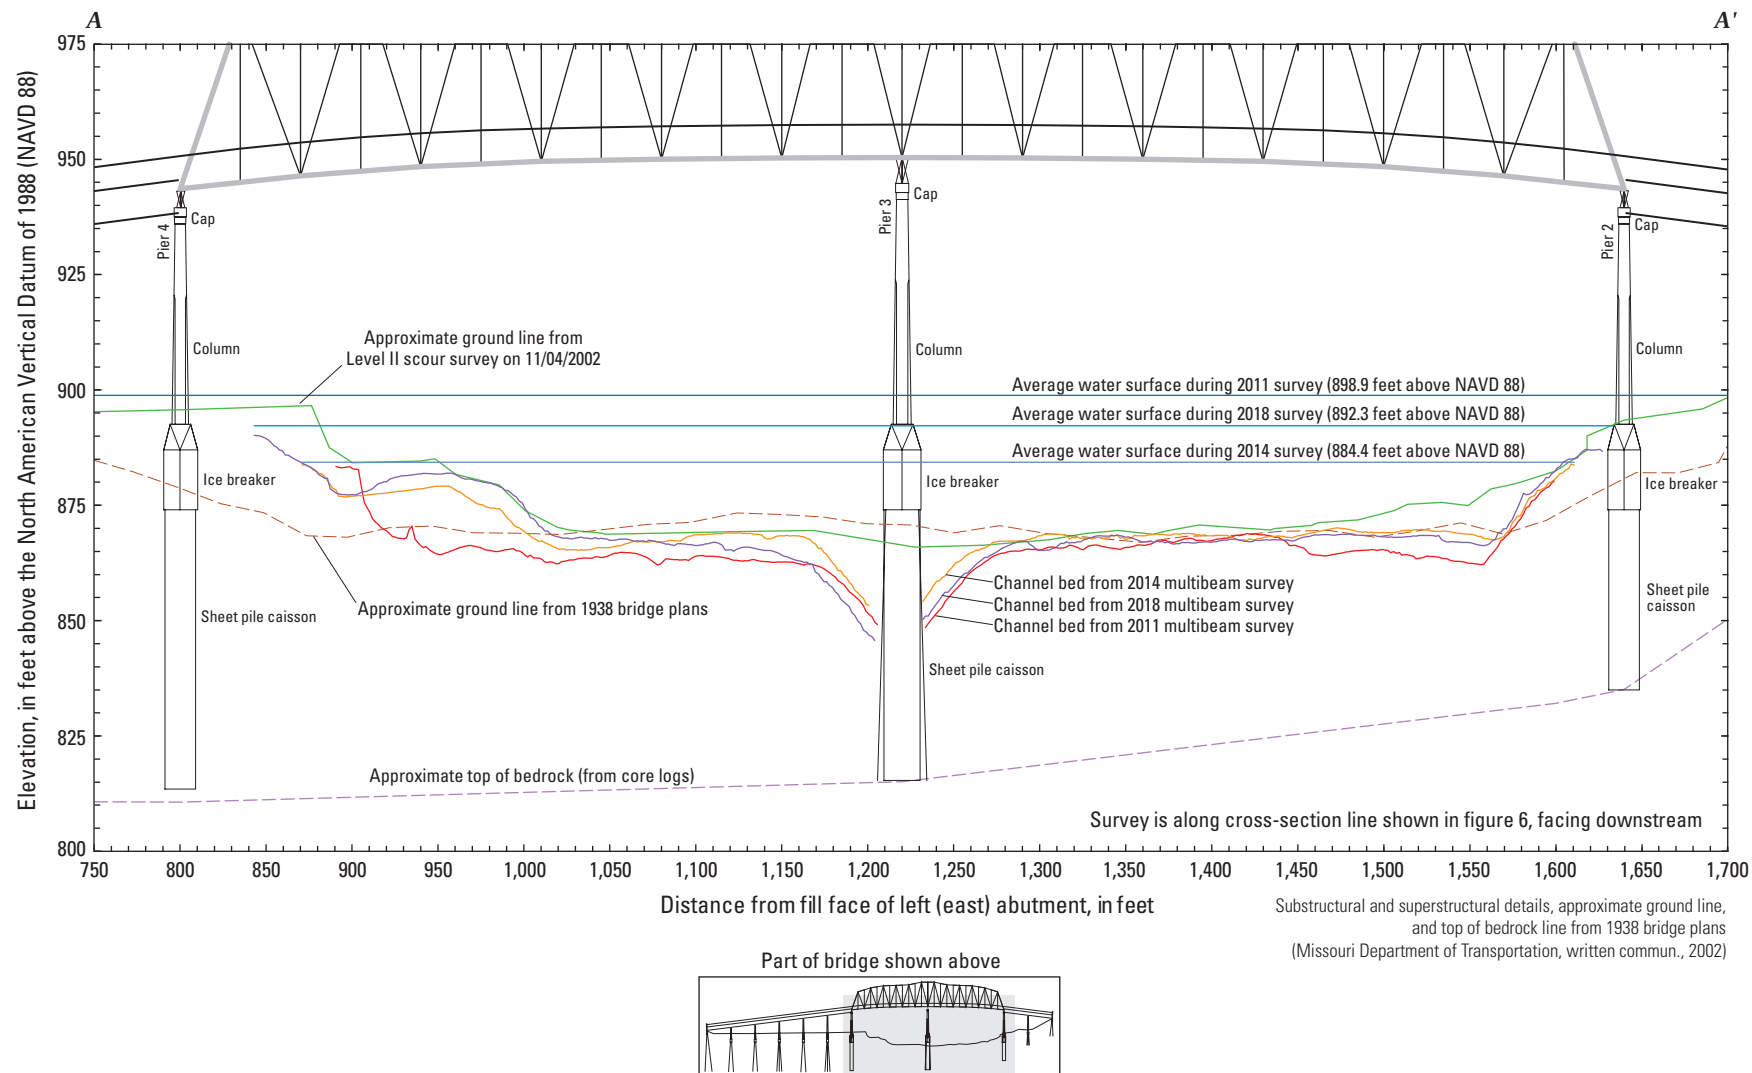
**Figure 8.** Key features, substructural and superstructural details, and surveyed channel bed of structure L0098 on U.S. Highway 136 over the Missouri River at Brownville, Nebraska.

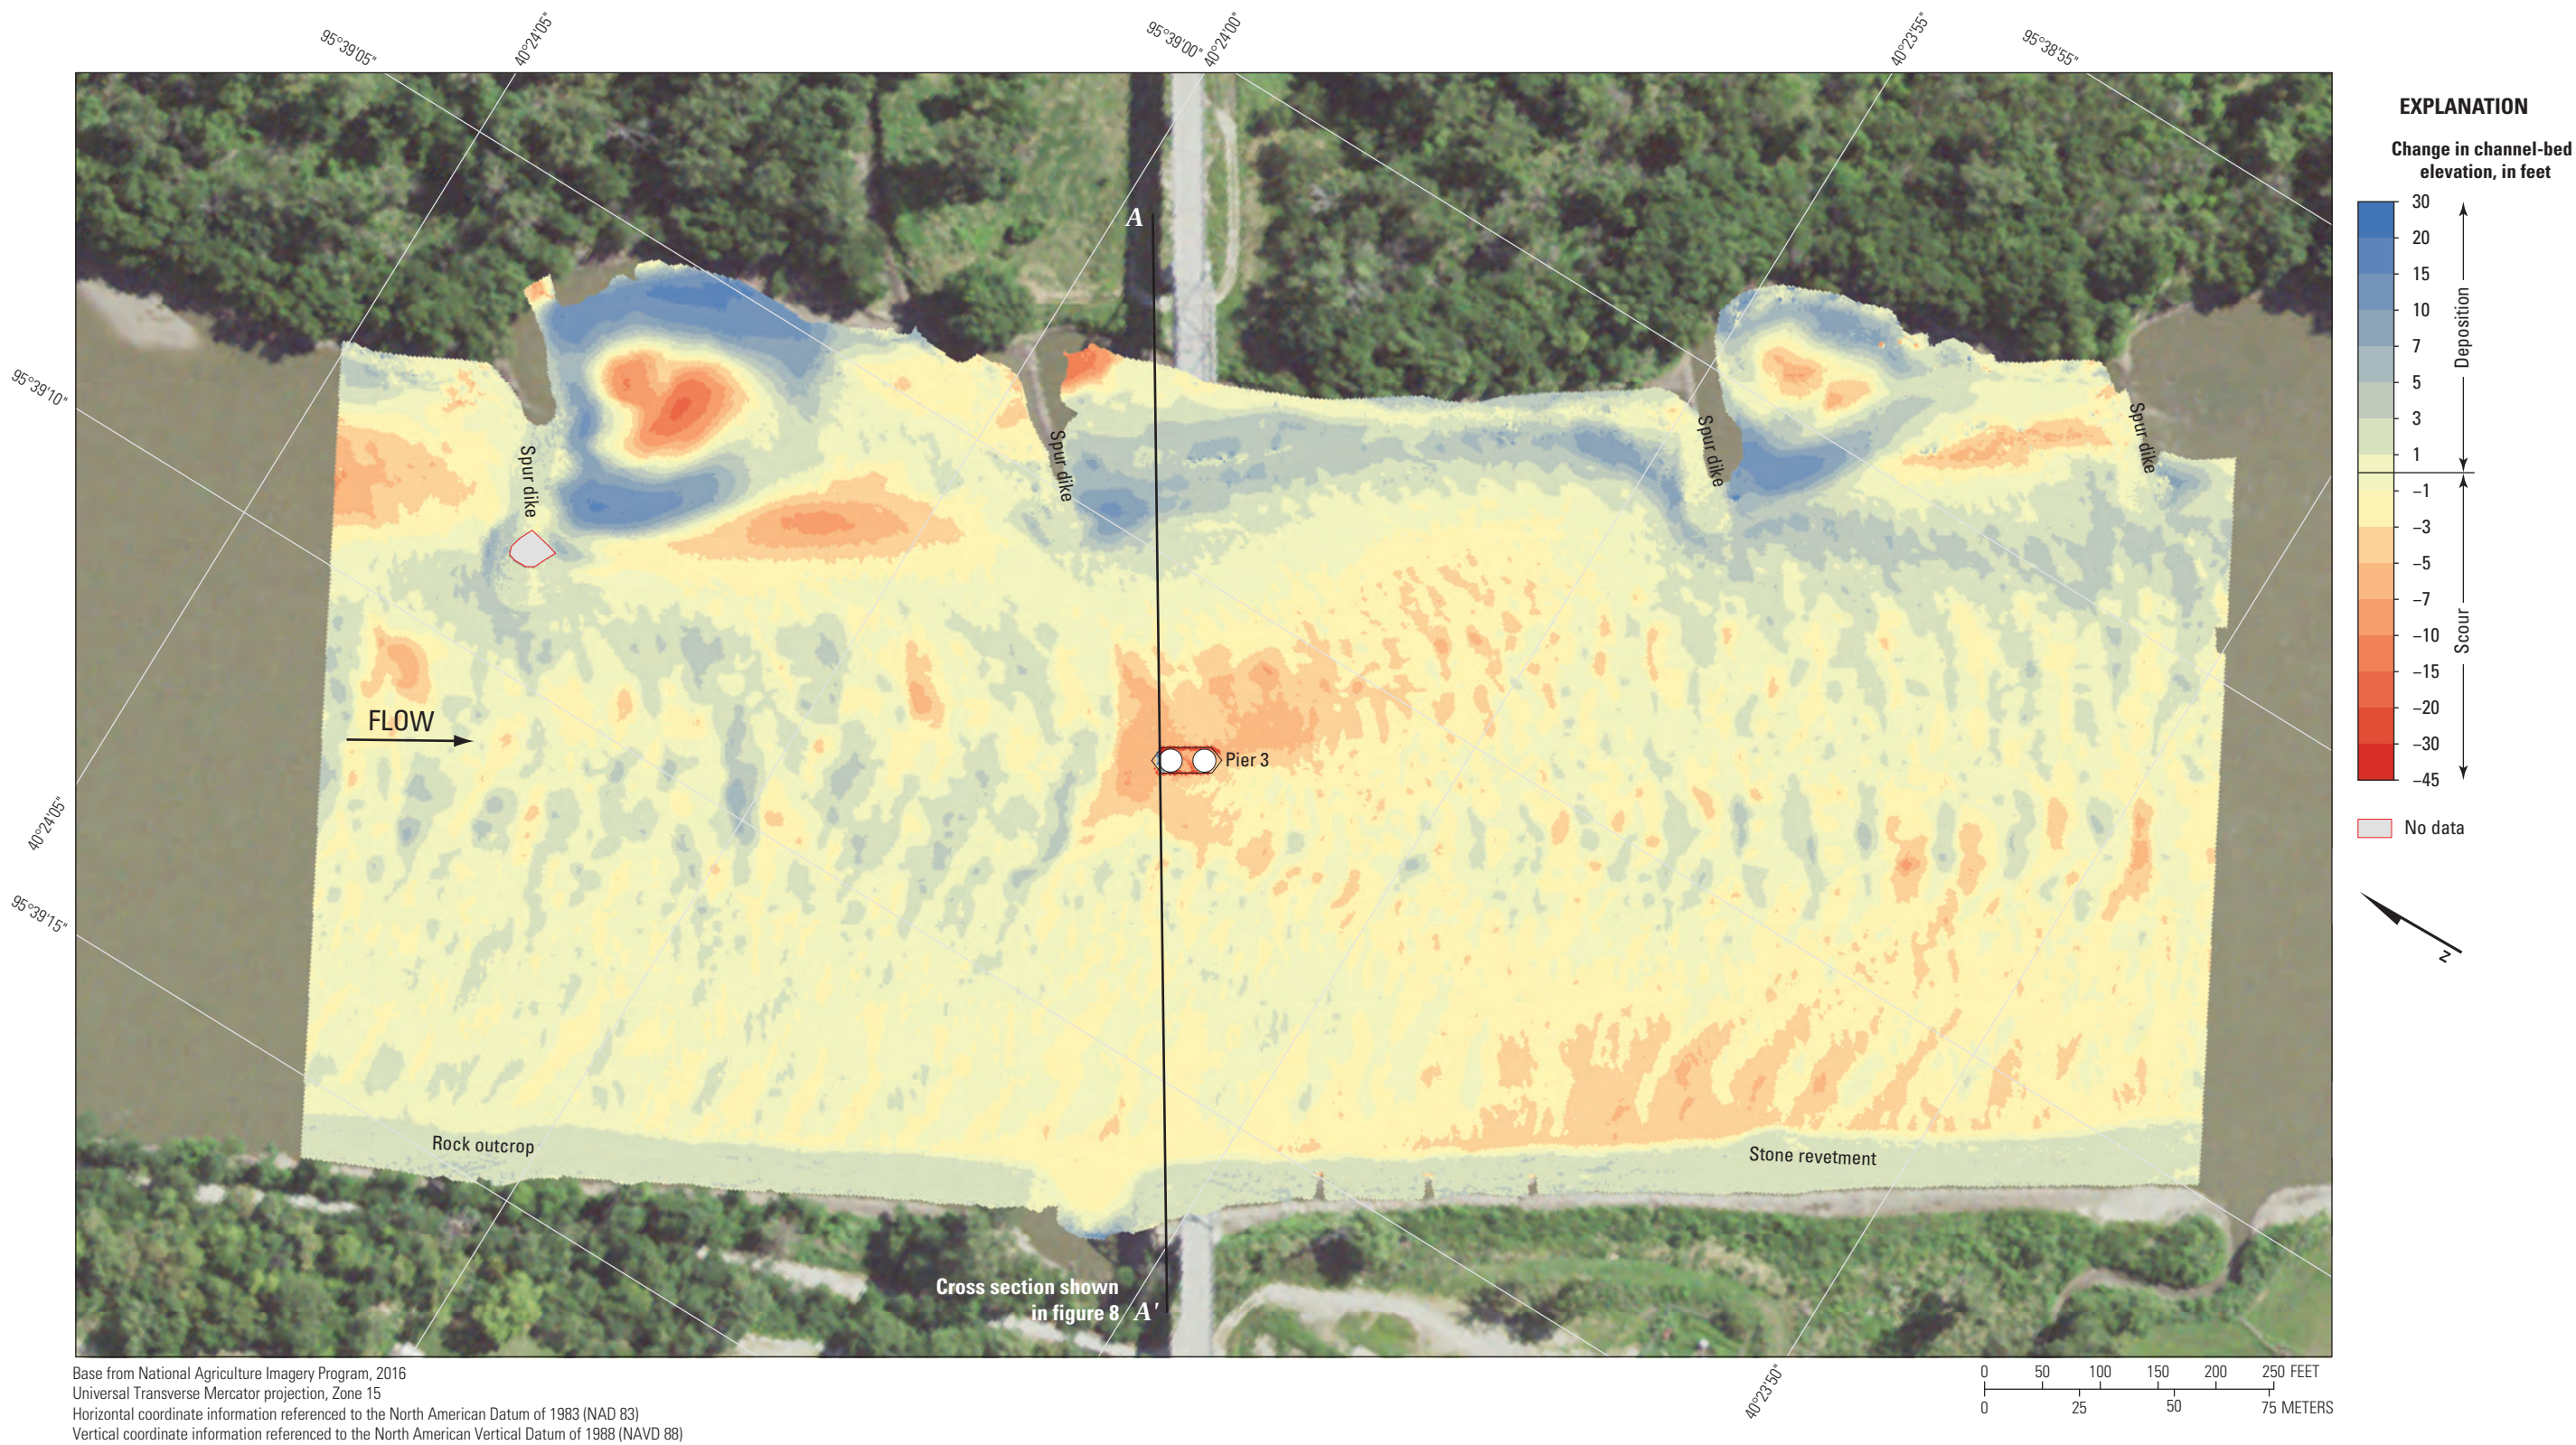
**Figure 9.** Difference between surfaces created from bathymetric surveys of the Missouri River channel near structure L0098 on U.S. Highway 136 at Brownville, Nebraska, on August 13, 2018, and June 3, 2014.

The difference between the survey on August 13, 2018, and the previous nonflood survey on June 3, 2014, indicates general deposition from 2014 to 2018, with moderate deposition of as much as 7 ft in the main part of the channel and substantial deposition of more than 20 ft (along with localized erosion of as much as 15 ft) near the spur dikes on the left (east) side of the channel (fig. 9). However, there were several areas of moderate scour of as much as 10 ft, particularly near the base of the right (west) bank downstream from the bridge, and in the area around and downstream from pier 3. Minor deposition of as much as 3 ft is indicated along the rock outcrop and stone revetment on the right (west) bank, but may be the result of minor positional variations between the surveys. The average difference between the bathymetric surfaces (the statistical average value of the gridded raster surface [fig. 9] created from the difference between the 2018 and 2014 [previous] survey gridded raster bathymetric surfaces) was +0.01 ft (table 8), indicating a general balance between aggradation

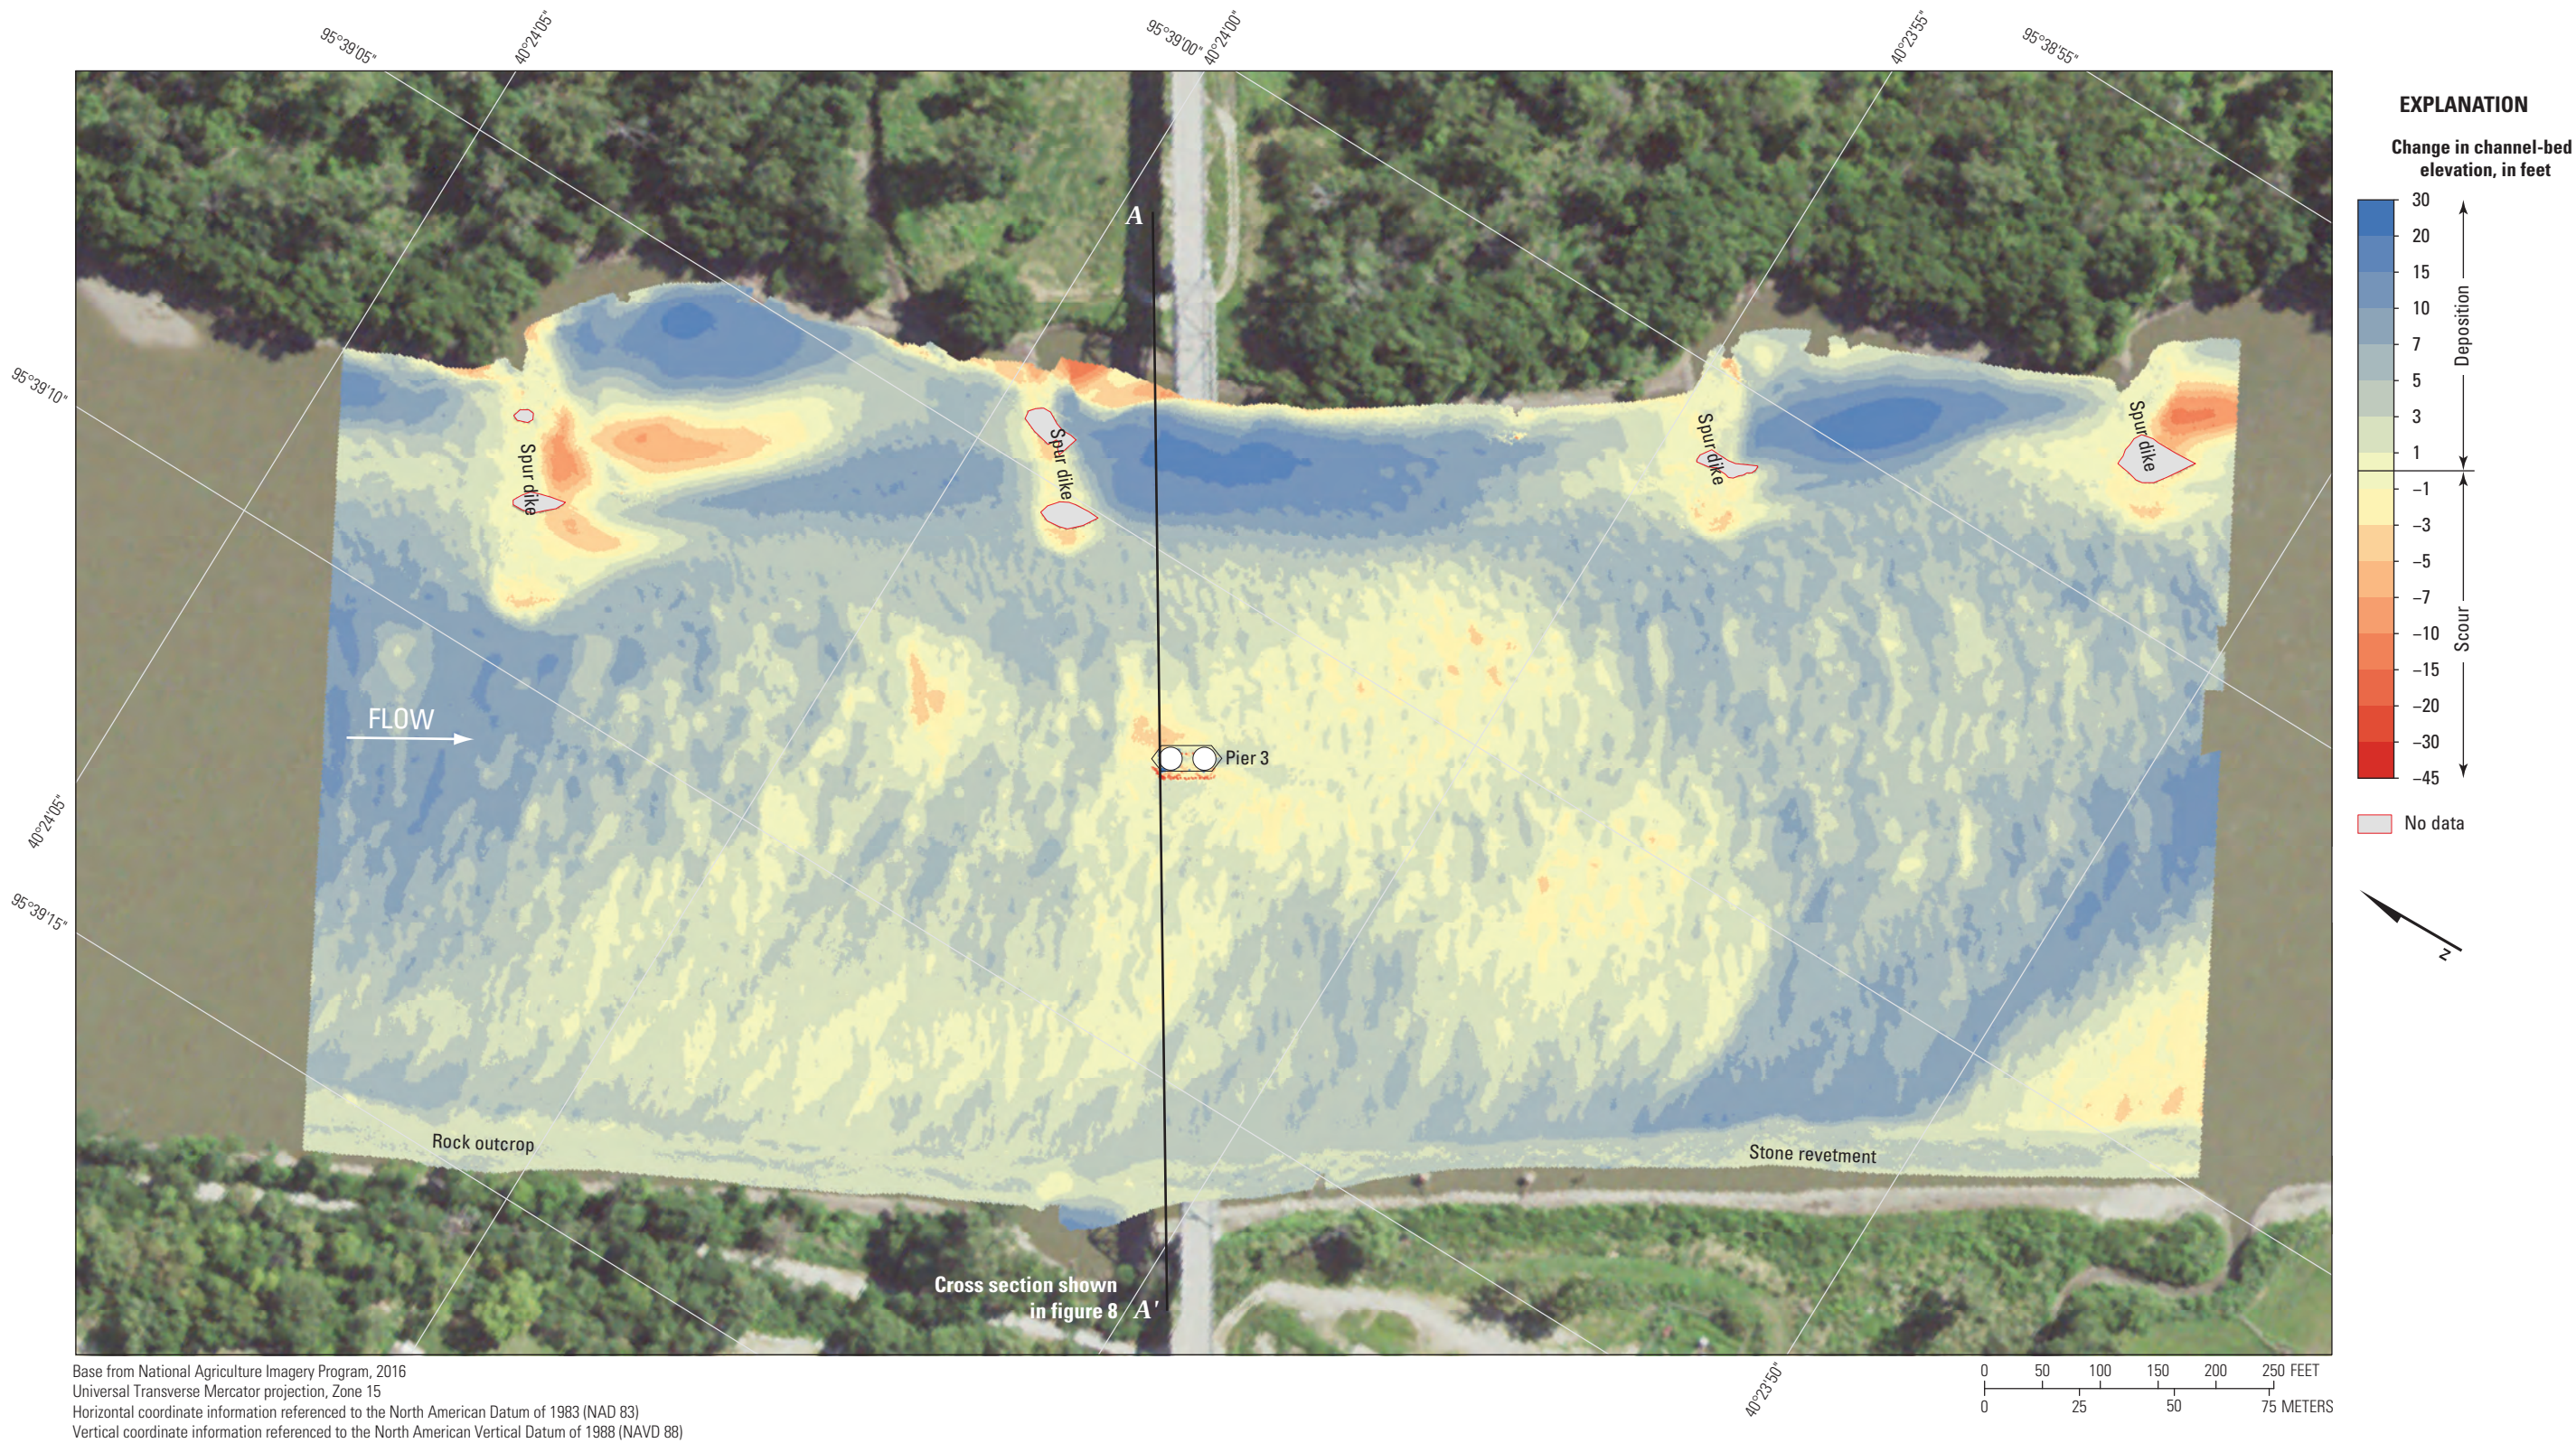
The difference between the survey on August 13, 2018, and the previous flood survey on July 13, 2011, indicates substantial deposition has occurred throughout the channel reach from 2011 to 2018 (fig. 10). Widespread moderate deposition of as much as 15 ft was observed upstream and downstream from the bridge, and more than 20 ft of deposition was observed downstream from the spur dikes on the left (east) bank (fig. 10). Small, localized areas of minor scour were observed immediately downstream from the spur dikes, near pier 3, and at the base of the right (west) bank at the extreme downstream end of the reach (fig. 10). Minor deposition of 3 ft or less indicated along the rock outcrop and stone revetment on the right (west) bank substantiates the probability of minor

**Figure 10.** Difference between surfaces created from bathymetric surveys of the Missouri River channel near structure L0098 on U.S. Highway 136 at Brownville, Nebraska, on August 13, 2018, and July 13, 2011.

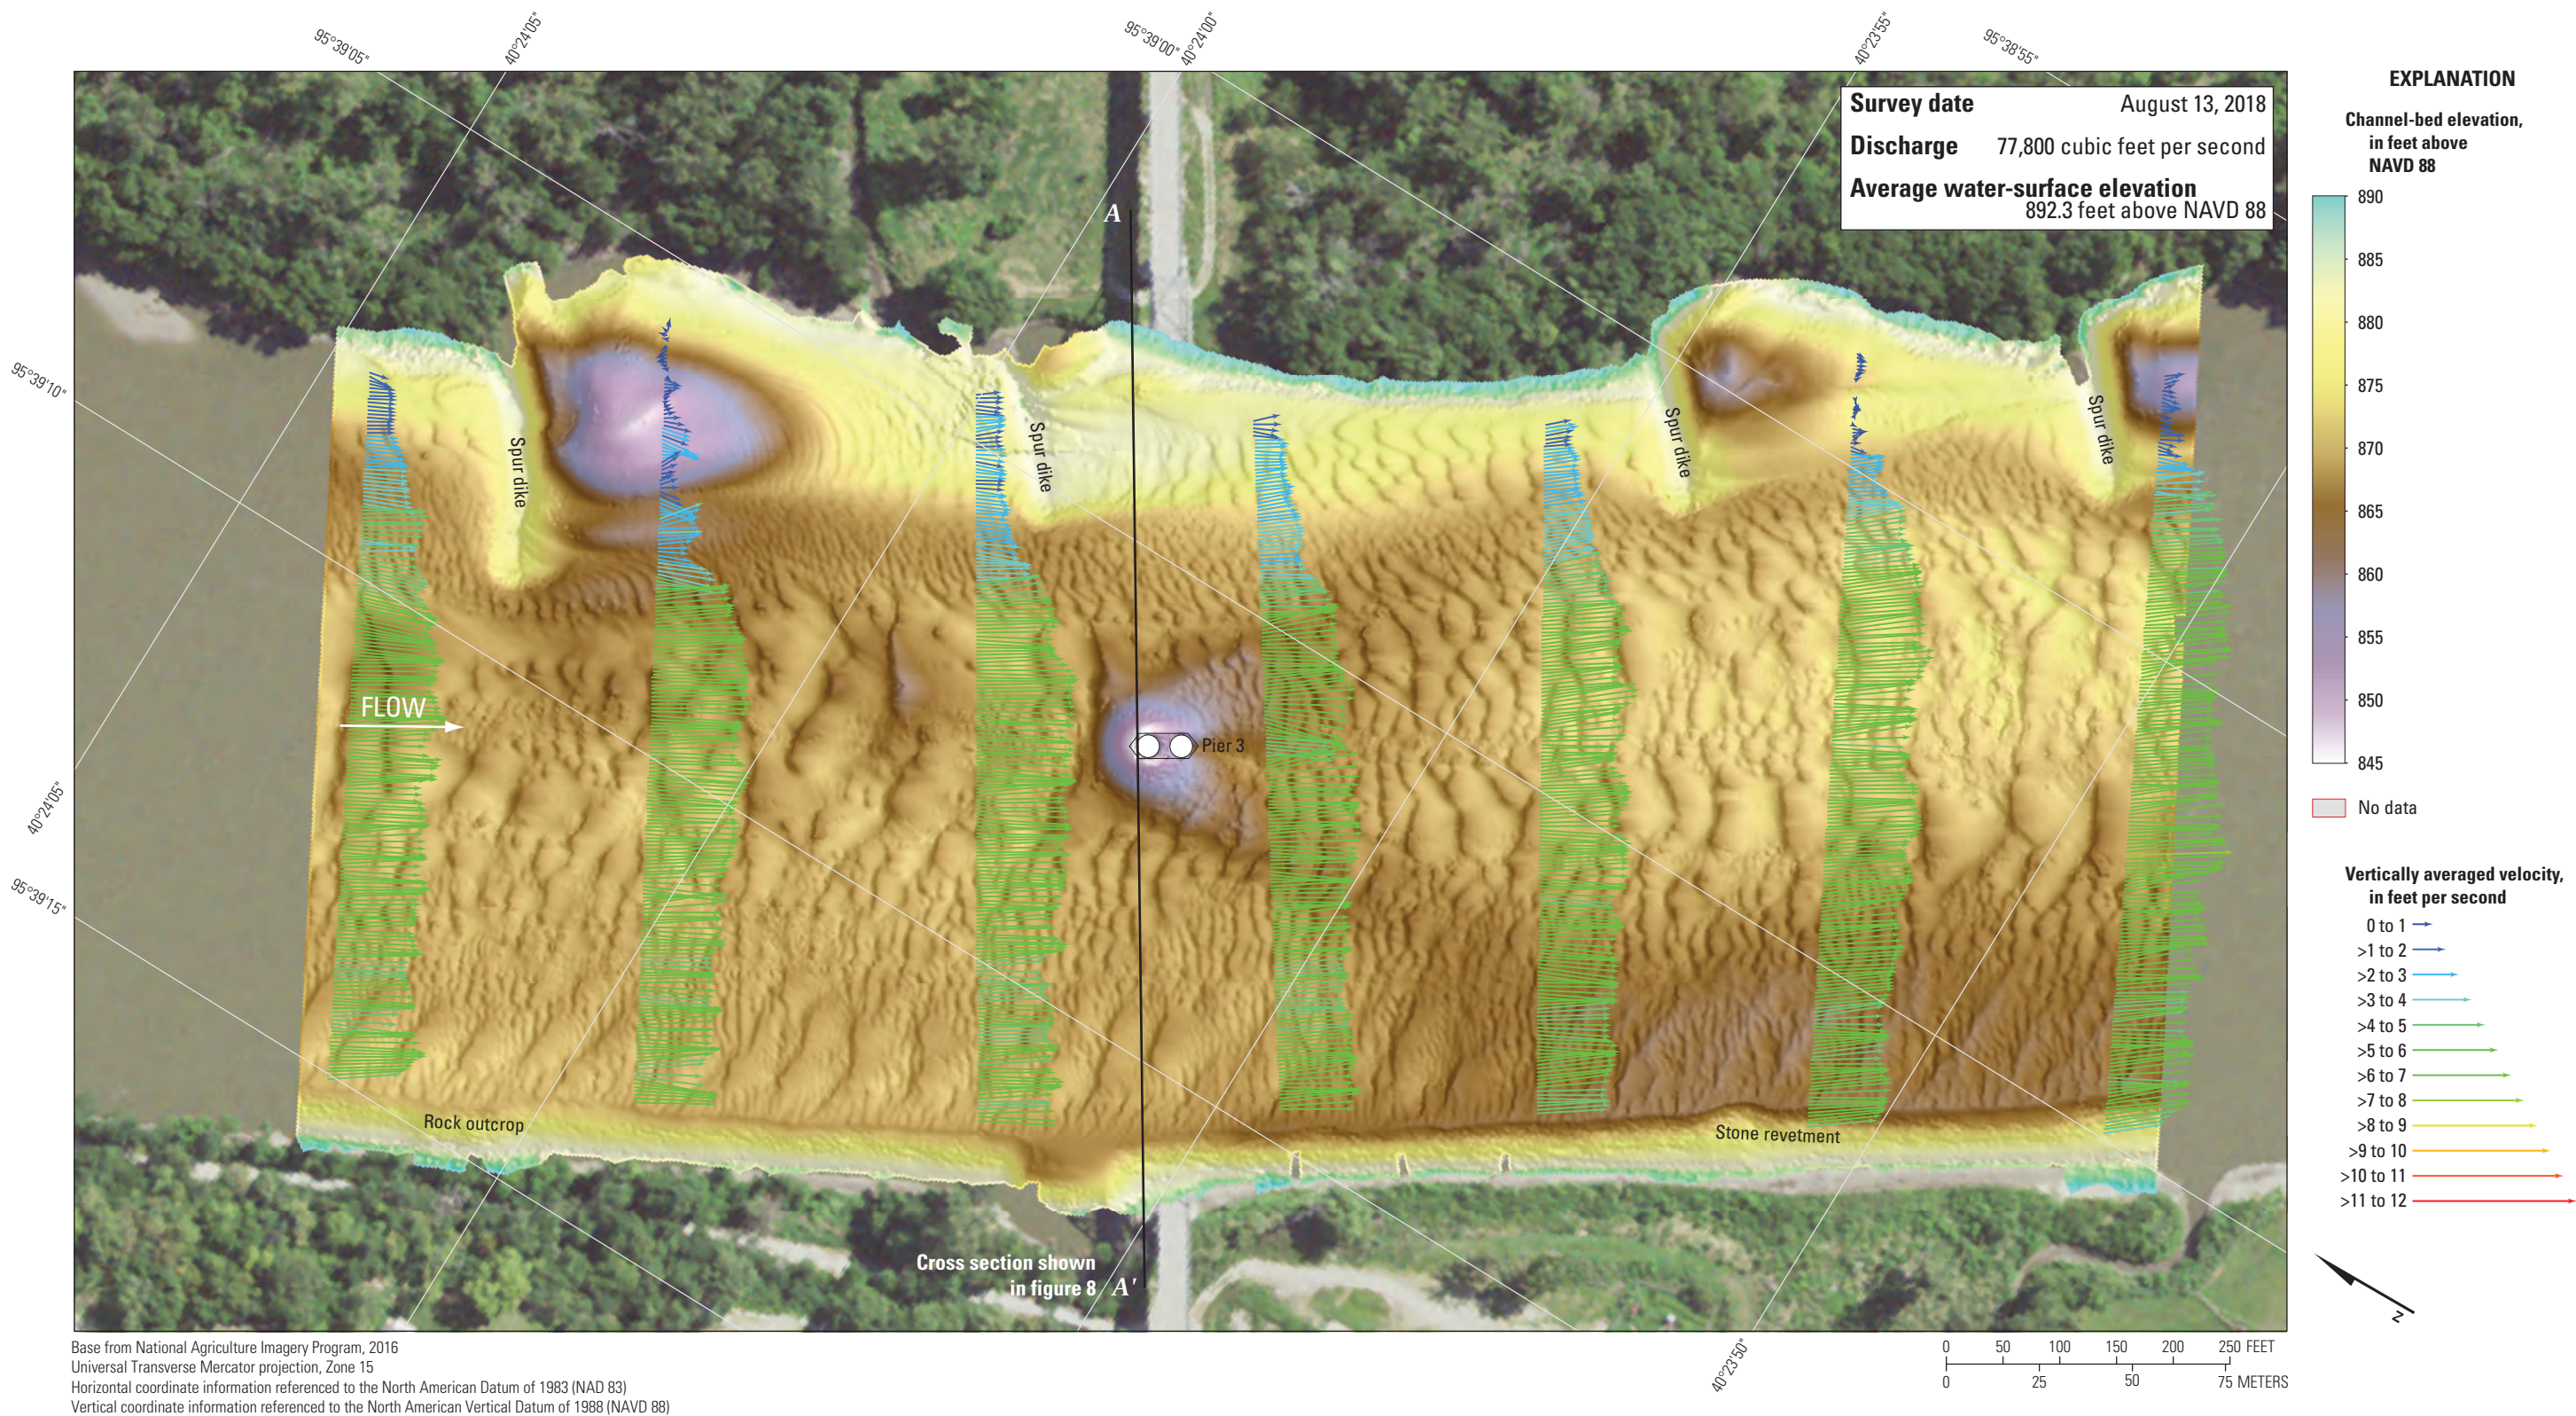
The vertically averaged velocity vectors indicate mostly uniform flow throughout the reach (fig. 11). A maximum velocity of about 8 feet per second (ft/s) was present in the upstream middle of the channel and a minimum of 1 ft/s with flow reversal was present downstream from the various spur dikes in the reach (fig. 11). The wake vortices downstream from pier 3 were not pronounced, and seemed to be no greater than the general non-uniformity of flow observed in the channel (fig. 11). Minor turbulence was present in all the sections (fig. 11).

**Figure 11.** Bathymetry and vertically averaged velocities of the Missouri River channel near structure L0098 on U.S. Highway 136 at Brownville, Nebraska.
